DEPARTMENT OF TRANSPORTATION**DIVISION OF ENGINEERING SERVICES**

Contract #: 04-0120F4Cty: SF/ALA Rte: 80 PM: 13.2/13.9File #: 1.28**WELDING INSPECTION REPORT****Resident Engineer:** Pursell, Gary**Address:** 333 Burma Road**City:** Oakland, CA 94607**Report No:** WIR-015030**Date Inspected:** 21-Jun-2010**Project Name:** SAS Superstructure**OSM Arrival Time:** 700**Prime Contractor:** American Bridge/Fluor Enterprises, a JV**OSM Departure Time:** 1530**Contractor:** American Bridge/Fluor Enterprises, a JV**Location:** Job Site**CWI Name:** See Below**CWI Present:** Yes No**Inspected CWI report:** Yes No N/A**Rod Oven in Use:** Yes No N/A**Electrode to specification:** Yes No N/A**Weld Procedures Followed:** Yes No N/A**Qualified Welders:** Yes No N/A**Verified Joint Fit-up:** Yes No N/A**Approved Drawings:** Yes No N/A**Approved WPS:** Yes No N/A**Delayed / Cancelled:** Yes No N/A**Bridge No:** 34-0006**Component:** Orthotropic Box Girders (OBG)**Summary of Items Observed:**

1. OBG Field Splice 3E/4E Face D (Outside) FCAW
2. OBG Field Splice 4E/5E Face C (Inside) FCAW
3. OBG Field Splice 4E/5E Face D (Outside) Backgouge

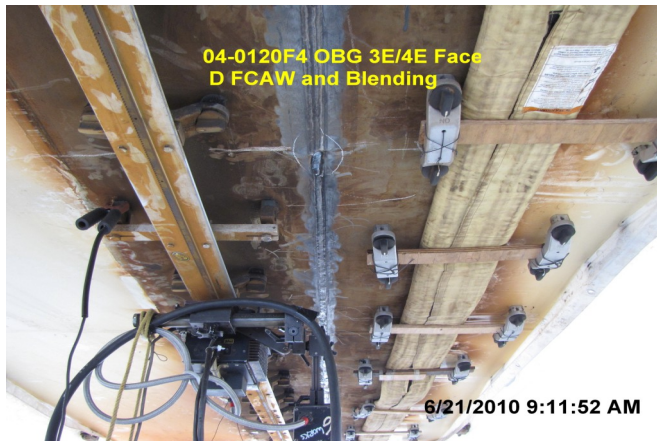
Field Splice 3E/4E Face D (Outside) FCAW

The QA inspector periodically observed the in process Flux Cored Arc Welding (FCAW-G) being performed in the 4G overhead position by ABF welding personnel Mitch Sittinger for the South ½ of face D. QC inspector Jim Cunningham was noted to be present in order to monitor the progress and ensure the welding parameters were within the established Welding Procedure Specification (WPS) noted as ABF-WPS-D1.5-3040B-4. At this time the welder and the helper are in the process of performing grinding operations in order to prepare several areas for welding. These areas have been identified by the welder and the QC inspector for grinding/blending and/or filling for weld layering purposes. The work continued throughout the QA inspector's shift, was not completed on this date and appeared to be progressing in general conformance with the contract documents. See digital photo included in the body of this report for general information.

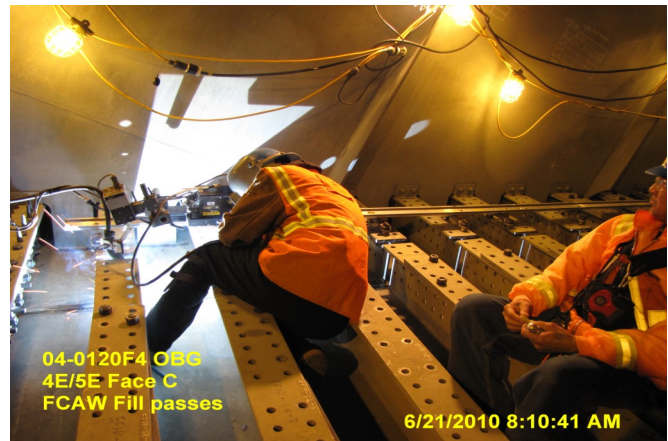
Field Splice 4E/5E Face C (Inside) FCAW

The QA inspector periodically observed the in process Flux Cored Arc Welding (FCAW-G) being performed by

ABF welding personnel Song Tao Huang between Y locations originating at Y location 5000mm from the longitudinal diaphragm. The welder is in the process of placing the fill passes at this time with approximately 80% being completed at the start of the shift. QC inspector Bernard Docena was noted to be present in order to monitor the progress and ensure the welding was within the established Welding Procedure Specification (WPS) noted as ABF-WPS-D1.5-3042B-1 and supporting Procedure Qualification Records (PQR). Prior to initiating the welding at this location the QC inspector observed the preheat temperature was not sufficient due to an equipment malfunction. The QC inspector immediately informed the welder and the welding foreman who rectified the equipment and the welder applied localized heating to bring the area into conformance. The preheat and interpass temperature was then verified by the QC and QA inspector to be greater than 93° C and the parameters were verified to be 252 amps, 23.8 volts with a measured travel speed of 310mm/min. The work progressed throughout the shift and appeared to be in general conformance with the contract documents. See digital photo included in the body of this report for general information.
